Subcontractor faulted for 2 deadly excavation cave-ins in 6 months, sued for \$50 million

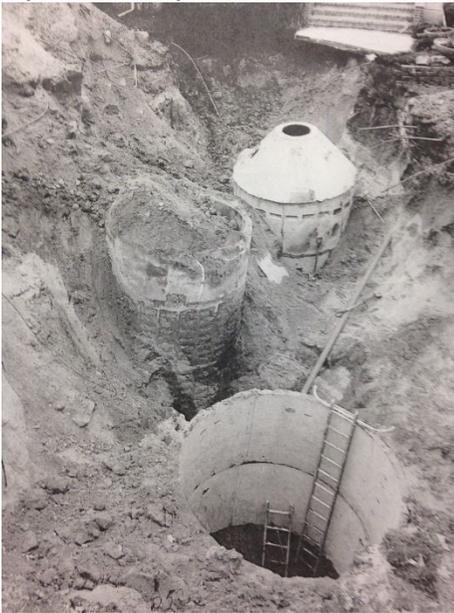
The scene after an excavation collapse at a cesspool installation site in Shoreham, New York, killed Kurt Peiscop-Grau on November 18, 2017. Source: OSHA investigation file

Around 11:20 a.m., the excavation collapsed and sucked down Peiscop-Grau. He was pinned between a concrete cesspool ring and the dirt that had covered him.

Because of the changes to the excavation from the recovery effort, rain and backfilling, the OSHA inspector could not determine the depth of the excavation before collapse, but estimated it to be anywhere from 17 to 23 feet deep and at least 20 feet wide.

"The ground had been disturbed several times, compromising its stability, information that Antorino would have known and understood to mean as such," says the OSHA report.

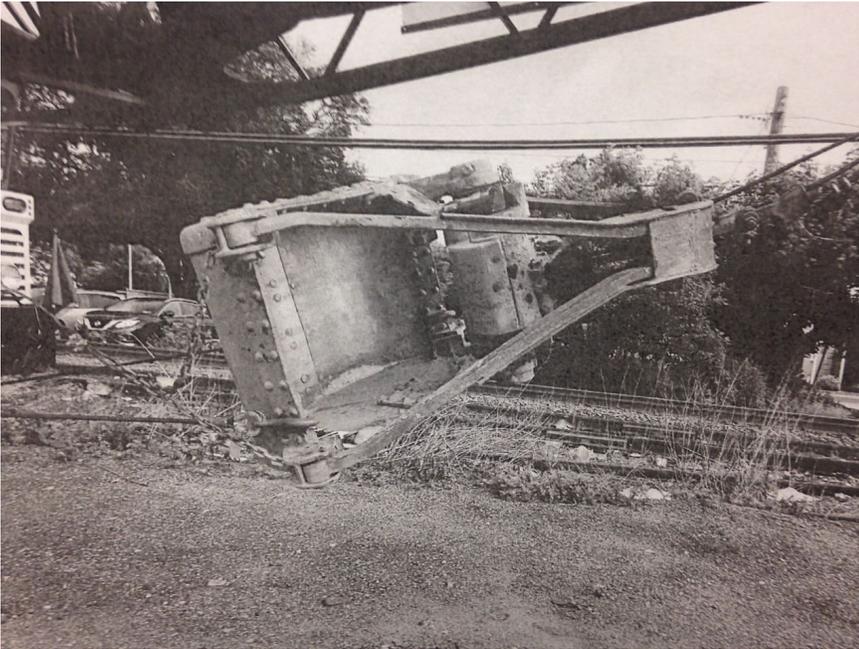
Don Antorino was using this clamshell bucket May 24, 2017, during a cesspool installation in Huntington. Bart Pember, CEO of PNZ Incorporated dba Antorino & Sons, was able to grab onto the bucket and was hoisted to safety. Source: OSHA investigation file

Sinnott, 60, had worked for Antorino for 2-1/2 years and was 5 to 6 feet deep in the excavation directing Antorino's bucket placement. The clamshell bucket was digging inside the 10-foot-diameter ring while Sinnott was standing beside the ring, according to the OSHA report. General contractor Bart Pember was beside Sinnott in the excavation, also giving hand signals.

Suddenly, the ground collapsed beneath Sinnott, and Pember grabbed the bucket and was lifted out. Sinnott was sucked into a 20-foot-deep hole, according to OSHA.

According to the OSHA report, Antorino said he might have removed too much soil from beneath one of the cesspool rings, causing instability and a void that pulled Sinnott in.
